TECHNICAL REPORT GL-79-20

INVESTIGATION OF BEACH SAND TRAFFICABILITY ENHANCEMENT USING SAND-GRID CONFINEMENT AND MEMBRANE REINFORCEMENT CONCEPTS

SAND TEST SECTIONS I AND 2

November 1979

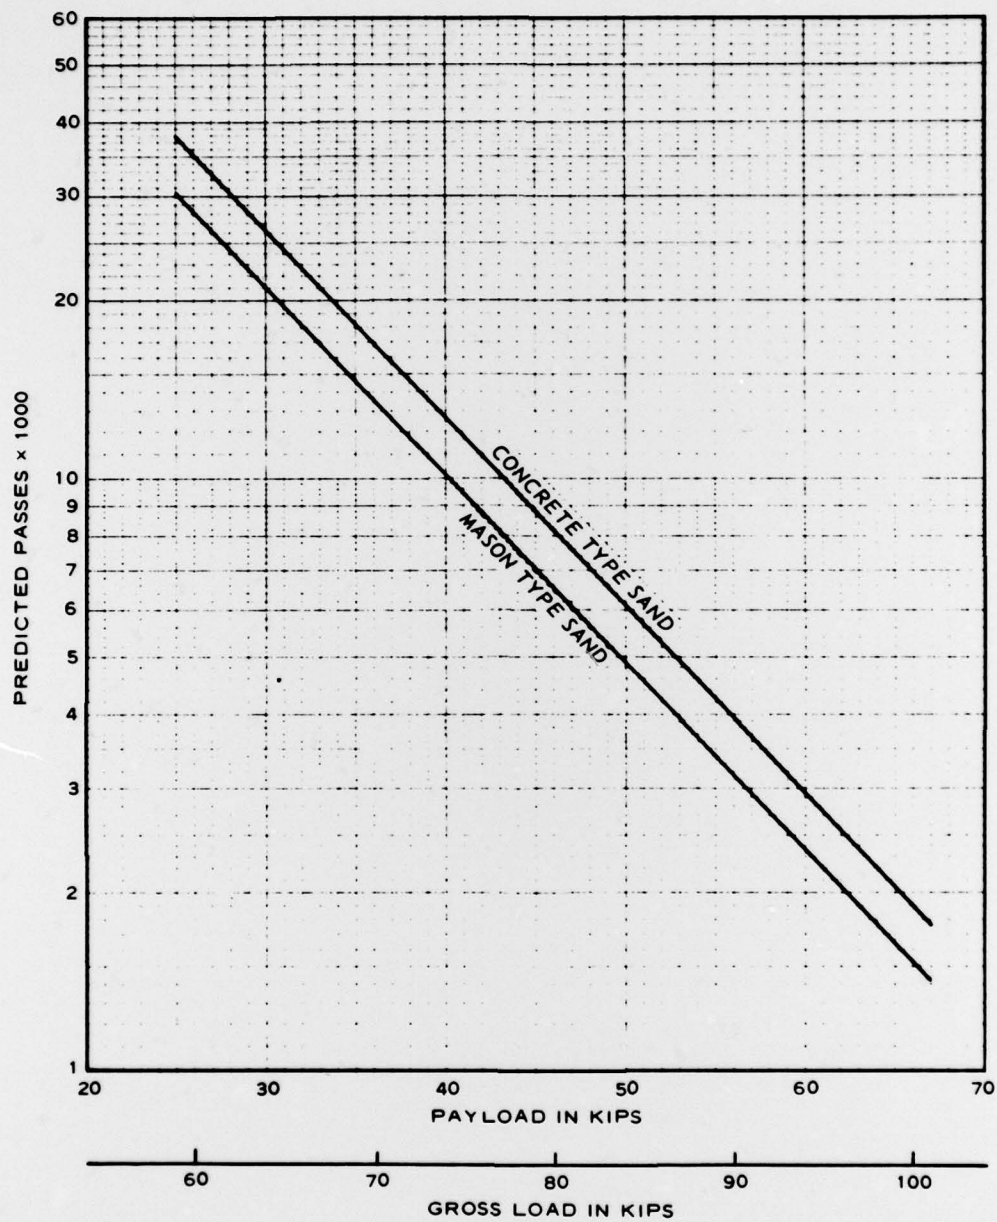
PREDICTED PERFORMANCE FOR
TRUCK SEMITRAILER (XM 878, XM 872)
CONTAINER OPERATIONS
OVER GRID-STABILIZED BEACH SAND

grids that have a 6-in. cell size and an 8-in. thickness. A sand-asphalt wearing surface is formed in the top inch of the grid cells. Assume containerships loaded with containers weighing up to 50 kips each. Then, if the maximum container payload hauled on a truck is limited to 50 kips, Plate 31 shows that the grid-stabilized sand will handle approximately 4900 passes of loaded container trucks before a 3-in. permanent depression develops at the grid surface. If, on the other hand, all trucks were loaded to the maximum payload of 67.2 kips, only 1400 passes could be applied.
